## White Paper

**Reducing  
Unplanned  
Production Downtime  
Instances Due to Replacement  
of M8 Proximity Sensors  
in Projection Welding Cell**

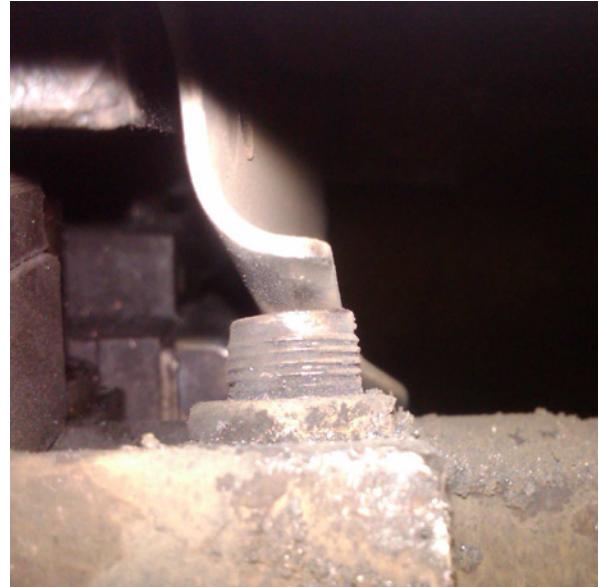
HTM performed an audit on this welding cell to determine which strategy will best eliminate cost and downtime related to this sensor application. There are 4 - M8 proximity sensors on this cell. These sensors are not only being damaged due to abrasion when parts are being manually loaded into the cell, but also by heat and weld spatter due to their close proximity to the weld.

The HTM Sensors Cost Reduction Vending System has identified that this projection welding cell had unplanned production downtime due to replacement of M8 proximity sensors. All of the broken sensors were damaged by abrasion, heat and weld spatter generated within this welding cell.

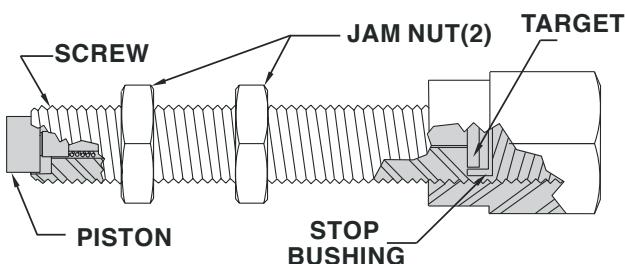
- 1) HTM Sensors proposed to install an M8 Banking Screw Adapter (BSA) in the harshest M8 sensor application on this cell. Banking Screw Adapters are designed to absorb impact and protect sensor from the excessive heat and spatter generated during welding. Banking Screw Adapters have been successful in similar applications at extending sensor life, reducing downtime, and increasing productivity.

Both the screw and piston are heat-treated to withstand heavy use. A connecting rod ties the spring loaded piston to a metal target, which triggers the sensor upon displacement of the piston. The sensor is separated and thus isolated from impact from the target by a plastic stop bushing. Two heavy-duty jam nuts or an optional threaded block mount secure the BSA.

- Stop travel and sense with one device
- Versatile outputs using any shielded sensor
- Isolates sensor from impact damage
- New applications for proximity sensors

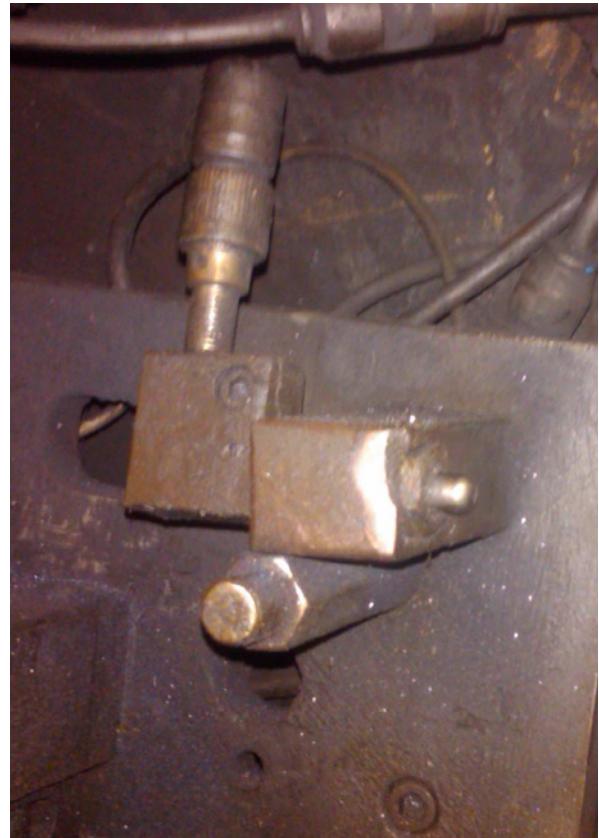
**50%**  
**REDUCTION  
IN USAGE**

ELIMINATION OF  
**72** UNPLANNED PRODUCTION DOWNTIME INSTANCES  
**\$4,536**  
ESTIMATED ANNUAL SAVINGS

Prior to the BSA installation, an average of 12 - M8 sensors per month were replaced on this cell. Since implementation of the BSA in this application four months ago, **M8 sensor replacement has dropped to an average of 6 sensors per month**. This **50% reduction in usage** will result in a projected **savings of \$4,536.00 annually** as well as the **elimination of 72 unplanned downtime instances**.
